J/70 Crew Positioning

The following photos are examples of proper and improper crew position under RRS 49. The photos used were from KWRW where there was still some confusion on the rule.

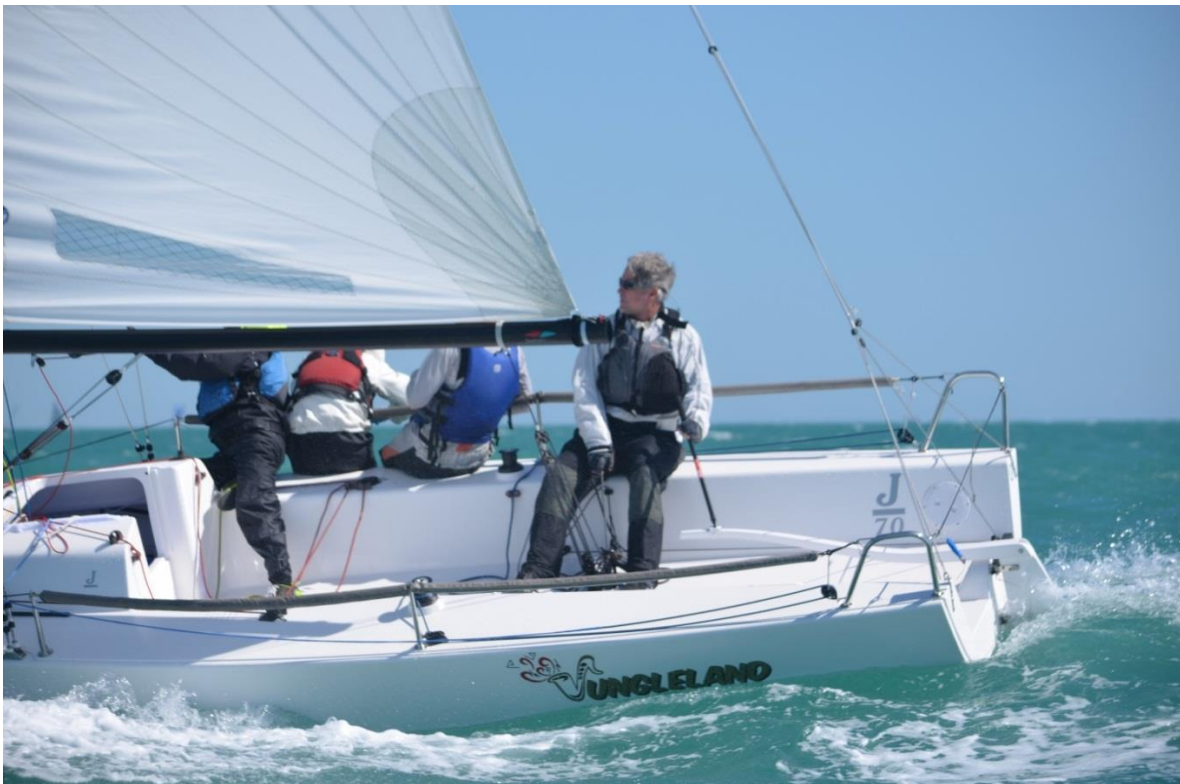
Notice the white jacket on same boat a few moments later. The base of spine is not on the deck. This is the test of proper crew position.
